Characteristics analysis of blade-casing rubbing based on casing vibration acceleration[†]

Abstract

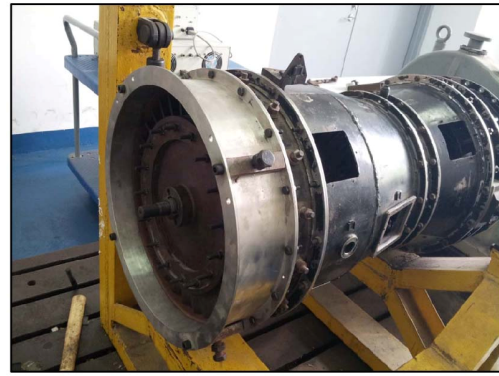
Fig. 7. Thick-walled casing after installation.

photograph before installation is shown in Fig. 6, and its physical map after installation is shown in Fig. 7. The single-point rubbing experiment conducted on the thick-walled casing is shown in Fig. 8. A schematic diagram of the rubbing measurement points on the thick-walled turbine casing is shown in Fig. 8. A comparison of Figs. 3 and 9 shows that unlike the thin-walled casing, on the thick-walled casing, the single-point rubbing positions are at the upper right, bottom right, bottom left, and upper left. However, the positions of partial rubbing are the same as those on the thin-walled casing.

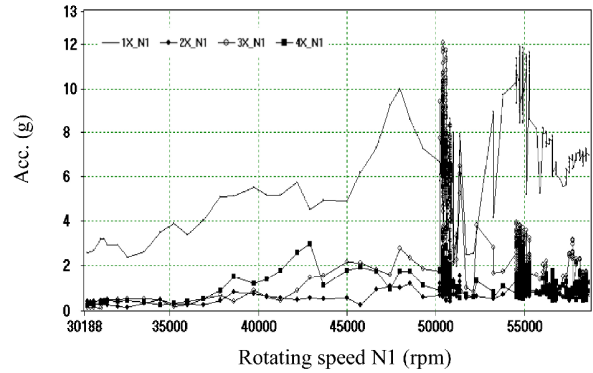
(a) 1x, 2x, 3x, and 4x components

(b) 1x, 2x, 3x, 4x, and effective value

Fig. 18. Vibration-speed relationship.

rotating speed are plotted in Fig. 18. Fig. 18(a) shows a plot of the changes in the 1x, 2x, 3x, and 4x components with the changes in rotational speed, and Fig. 18(b) shows the changes in the 1x, 2x, 3x, and 4x components and the effective value with changes in the rotational speed. From Fig. 18, the following can be observed: 1) as the rotational speed increases from 30,000 rpm to 50,000 rpm, vibration acceleration increases gradually, but there is considerable fluctuation close to 50000 rpm; 2) All other rotating speeds except 50000 rpm, the 1x component is much larger than 2x, 3x, and 4x components, but near 50000 rpm, the 3x component is larger than 1x component, from Fig. 18(b), the vibration effective value near

50000 rpm reaches 110 g, and much larger than other speeds.

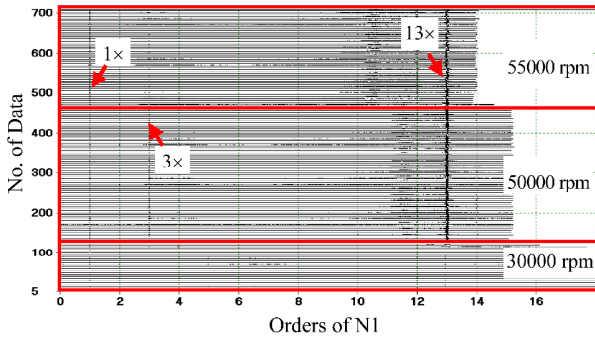
Fig. 19. The 3D waterfall plot of the S1:125-350 s.

Here, the rotating speed is defined as N1. The whole process is divided into three segments: S1:125-350s, S2:350-600s, and S3:600-850s. Figs. 19-21, respectively, show the 3D waterfall plots of the three segments' vibration signals. From these plots, it can be seen that there is no $13 \times N1$ component as the rotational speeds are near 30000 rpm. However, as the rotational speeds rise over 50000 rpm, there is an obvious $13 \times N1$ component, and the number of the engine compressor blades is right 13.

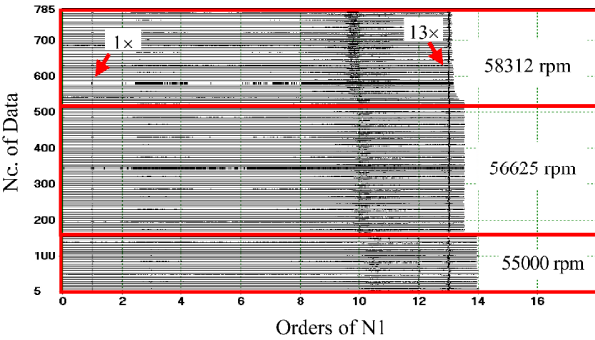
Fig. 20. the 3D waterfall plot of the S2:350-600 s.

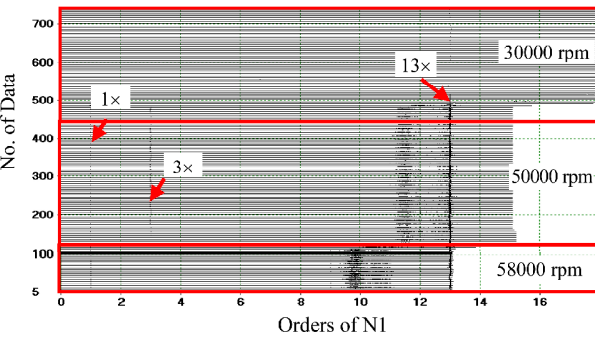
Fig. 21. the 3D waterfall plot of the S3:600-850 s.

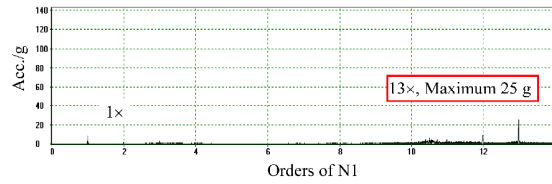
Fig. 24. Frequency spectrum (54750 rpm).

Figs. 22 and 23 are the frequency spectrums of rotating speed 50812 rpm, and Fig. 23 is the longitudinal coordinate enlargement of Fig. 22. Figs. 24-26 are, respectively, the frequency spectrums of rotating speed 54750 rpm, 56625 rpm, and 58500 rpm. From Fig. 22, the $13 \times N1$ component reaches 140g, and there is a sideband on both sides of the $13 \times N1$

component, and the sideband's interval is $N1$; and from Fig. 23, the $3 \times N1$ component is obviously larger than the $1 \times N1$ component. However, as shown in Fig. 24, the $13 \times N1$ component is only 25 g as rotating speed 54750 rpm; only 20 g as rotating speed 56625 rpm as shown in Fig. 25; and only 40 g as rotating speed 58500 rpm as shown in Fig. 26. In addition, the $12 \times N1$ component and the $14 \times N1$ component near the $13 \times N1$ component are all very small; in low frequency segments, the $1 \times N1$ component is obviously larger than the $2 \times N1$ component and $3 \times N1$ component.
